CROCKER LTD

Statement of Qualifications

Architectural Conservation

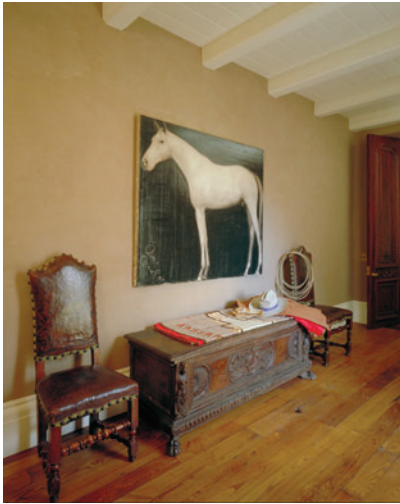
Tan mud, hard-troweled.

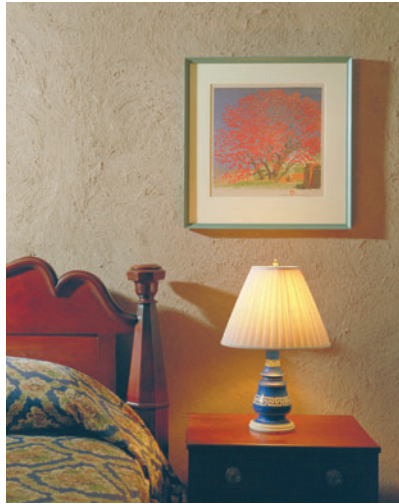
Tan mud with a textured finish.

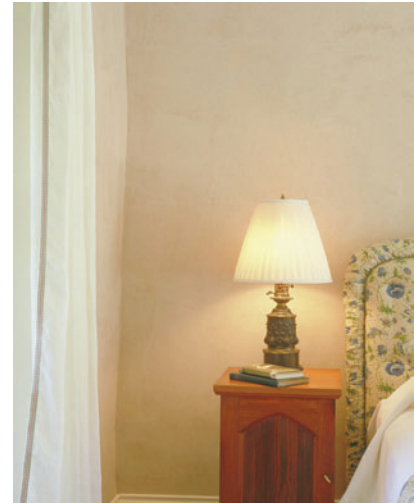
White mud plaster, naturally occurring and applied unamended.

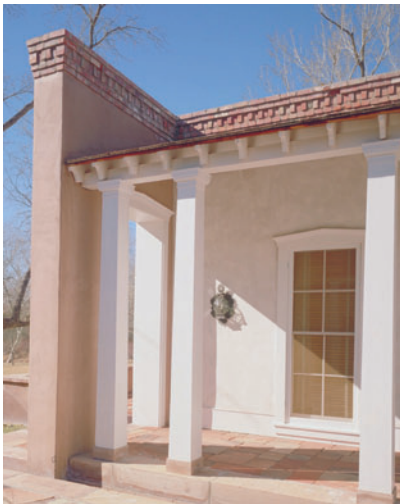
Exterior lime plaster.

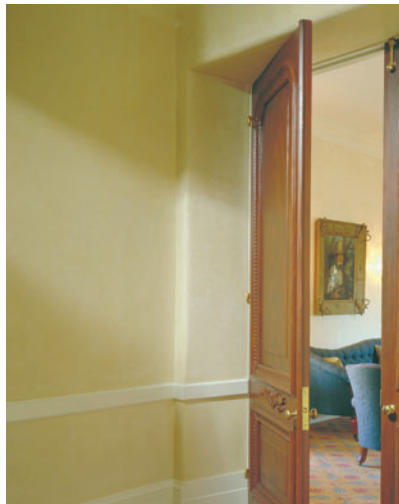
Naturally pigmented gauging plaster.

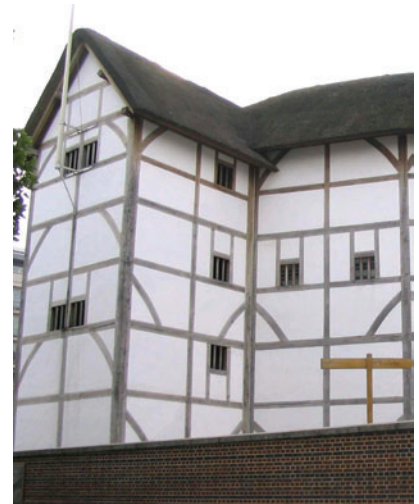
Exterior lime plaster at the Globe Theatre reconstruction.

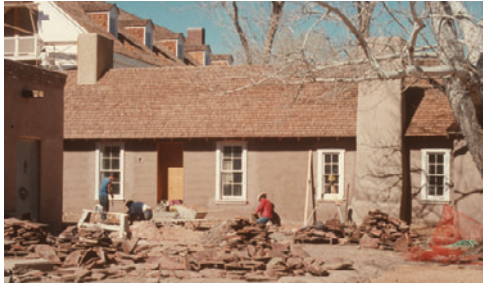
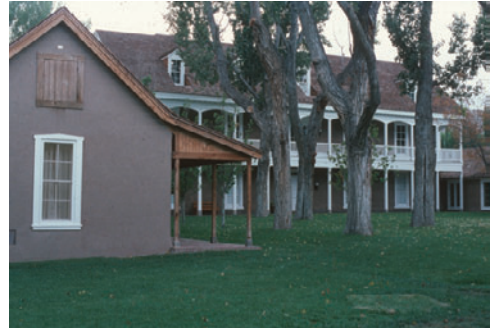
Diamond A Ranch, Hondo, New Mexico

Part of the ranch complex included an 1850s farmhouse on rubble footings. Once the footings were stabilized, the damaged walls were repaired and mud plastered.

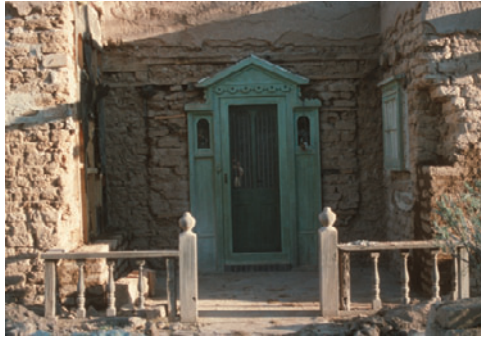
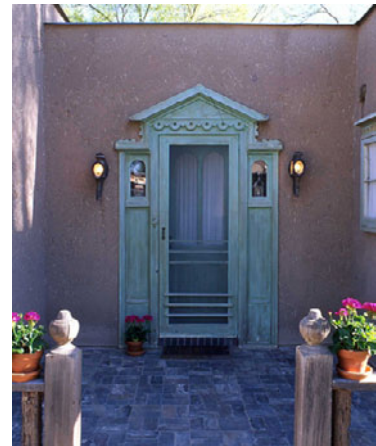
Nathaniel Owings' Estate, Jacona, New Mexico

Years of deferred maintenance and poor drainage had left the adobe walls in very poor condition. After repairing the walls, the parapets were capped with copper and a redundant drainage system was installed at the wall base to save the walls from future moisture intrusion.

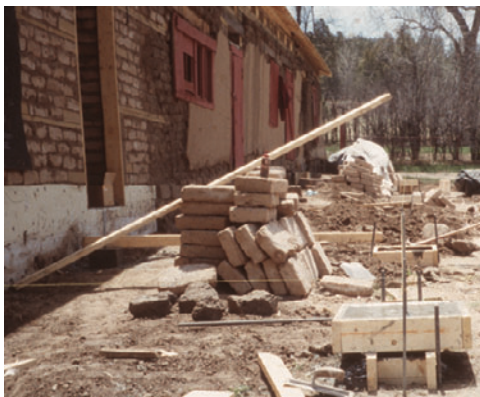
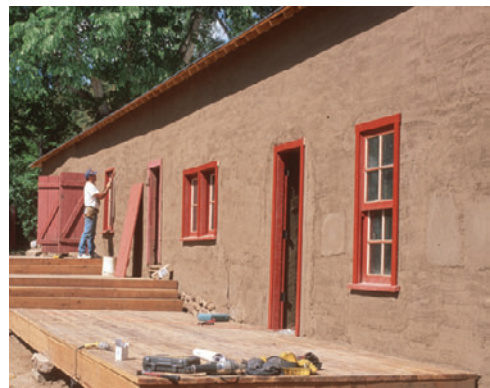
69 Ranch, Buena Vista, New Mexico

Broken flashing, groundwater and the buildup of debris next to the buildings led to partial collapse of the walls. After stabilization, the walls were restored, vigas spliced and a new roof applied.

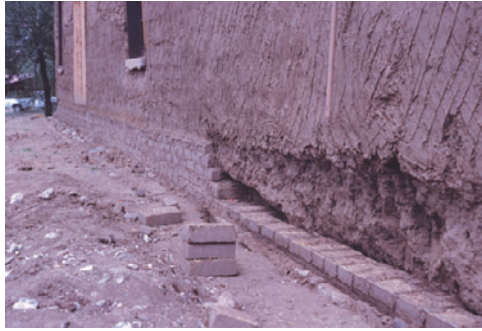
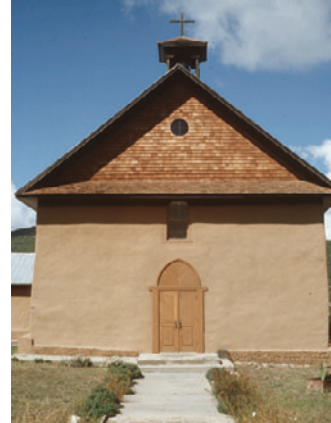
Nuestra Señora de los Dolores, Arroyo Hondo, New Mexico

Concrete grade beams and cement plaster led to severe deterioration of the adobe, particularly at the wall base. Once the concrete was removed, the walls were repaired and the building mud plastered.

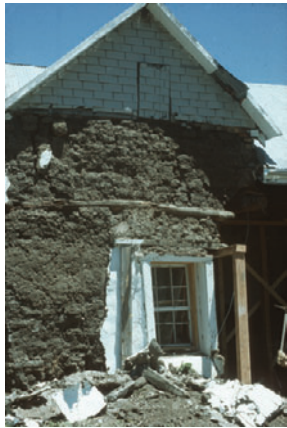
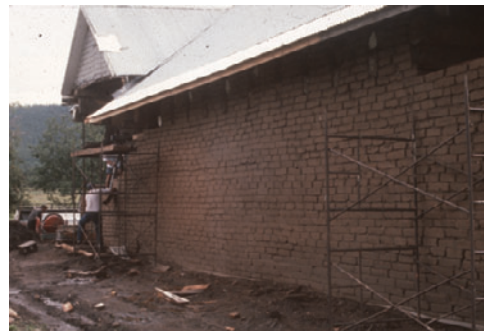
San José Mission, Upper Rociada, New Mexico

Poor drainage and a buildup of debris caused moisture infiltration and the collapse of the wall. The wall had to be demolished and was rebuilt using adobe and wooden tie beams.

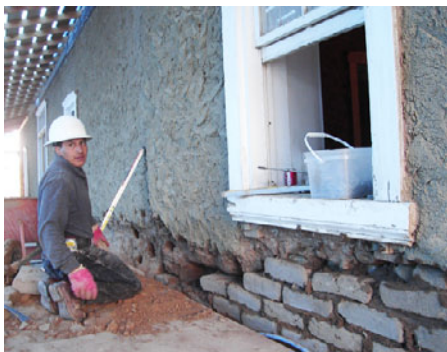
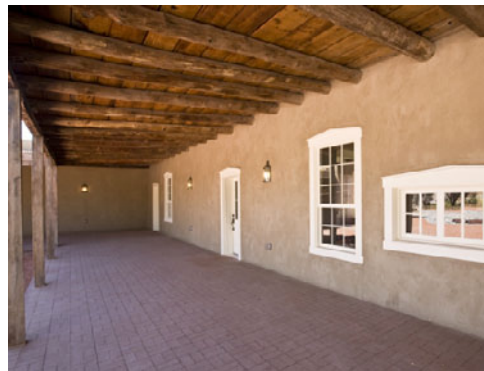
Gutiérrez-Hubbell House, Bernalillo County, New Mexico

This complete restoration included the reconstruction of several adobe walls and wall bases. The project, completed on time and on budget, earned Crocker Ltd the highest contractor rating possible from the owner, Bernalillo County.

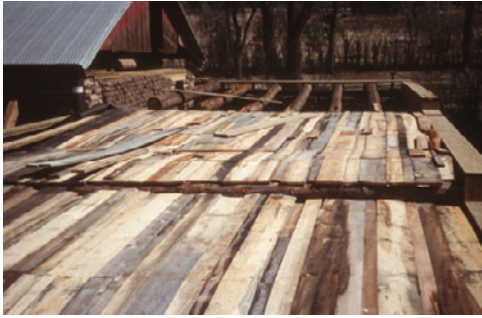
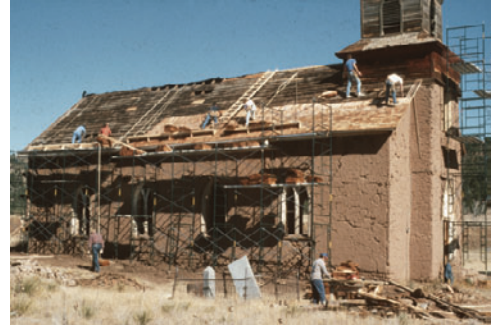
San Rafael Church, La Cueva, New Mexico

The historic cedar shingle roof on the church was stripped, the old wooden purlins repaired/replaced and new shingles applied.

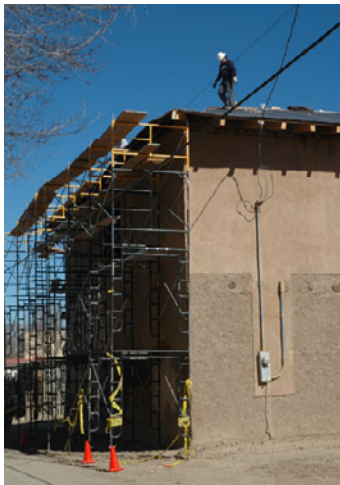
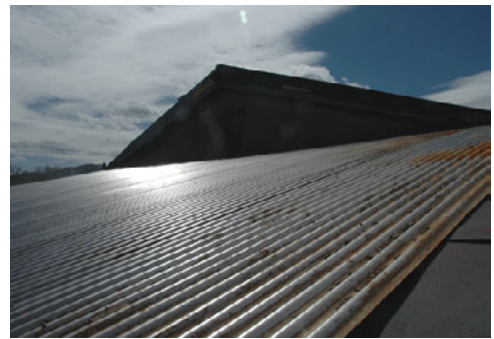
Andy's La Fiesta, Ranchos de Taos, New Mexico

An existing pitched tin roof over 50 years old had failed. Before re-decking, insulating and re-roofing, stabilization of the site-built trusses was required.

2007-2008. Andy's La Fiesta, Ranchos de Taos, NM. Structural stabilization, moisture remediation, and restoration services for former dance hall/saloon, one of the original structures on the Ranchos de Taos Plaza.

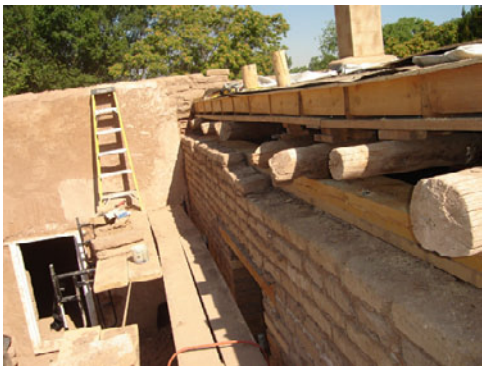
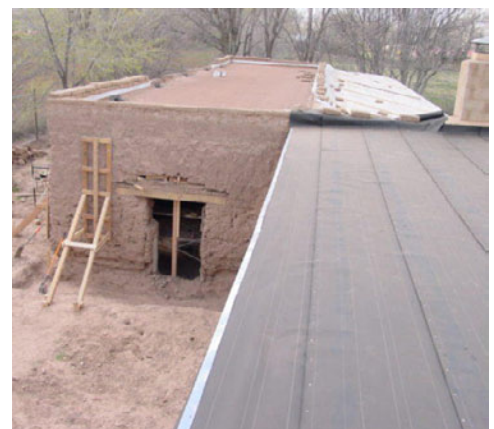
Gutiérrez-Hubbell House, Bernalillo County, New Mexico

The old earthen roof, covered over the years by several layers of asphalt roofing, had retained considerable amounts of moisture. The roof was stripped, a pocket roof was framed in, insulated, decked and re-roofed.

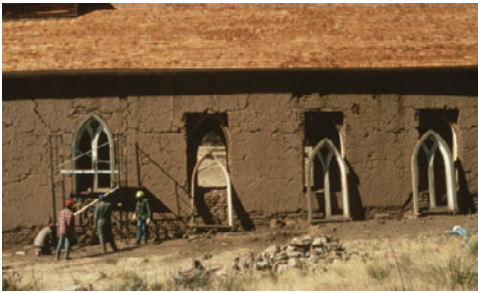
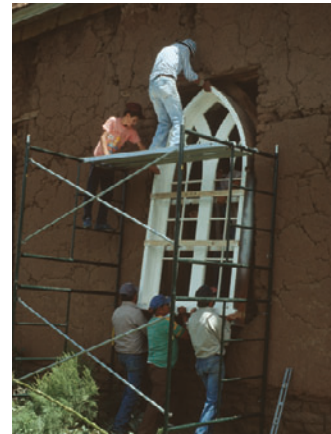
San Rafael Church, La Cueva, New Mexico

The building had been abandoned and vandalized for nearly thirty years. The full restoration included restoring the intricate gothic windows.

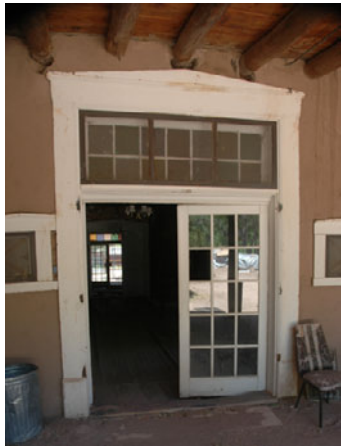
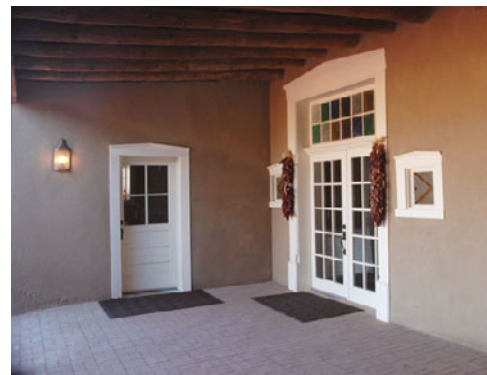
Gutiérrez-Hubbell House, Bernalillo County, New Mexico

This complete restoration of an important building in Albuquerque's South Valley included the rehabilitation of all existing windows and doors.

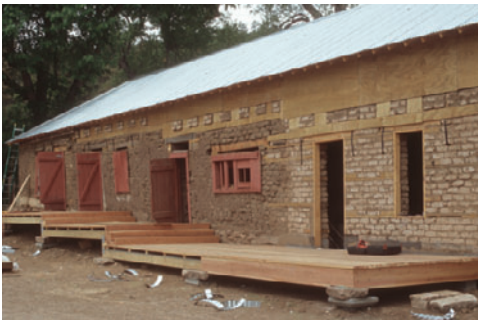
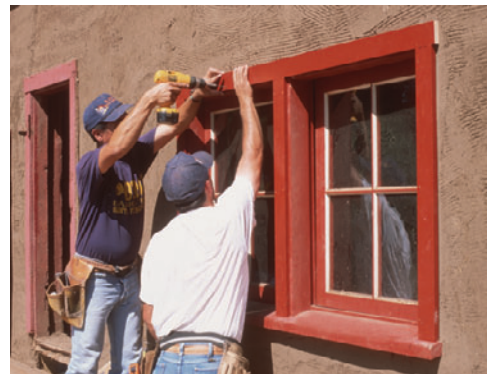
69 Ranch, Buena Vista, New Mexico

The window sashes were deteriorated beyond repair before the restoration of this historic adobe barn and blacksmith shop. Our approach was to replicate the woodwork, install restoration glass and use the old weights and hardware in the new units.

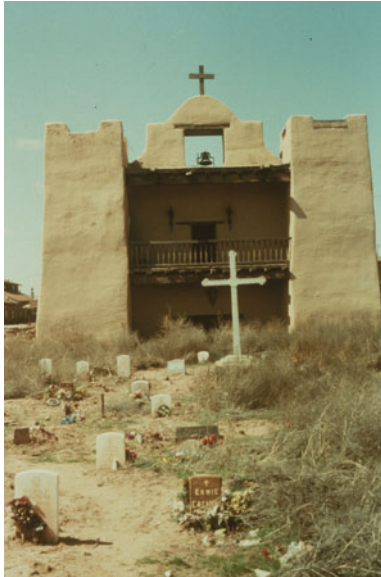
Nuestra Señora de Guadalupe Zuni, New Mexico

Exposed viga tails that had been installed during a 1970 reconstruction had lost their structural value. They were repaired in situ using fiberglass rods and epoxy.

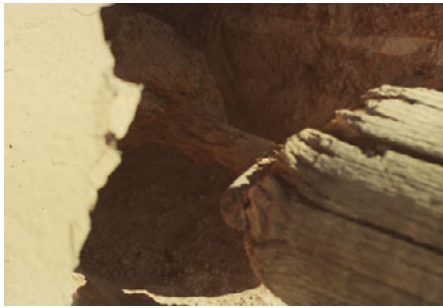
Rotted viga ends were discovered.

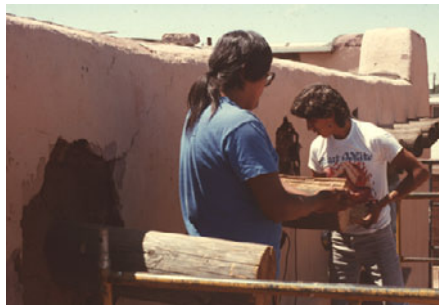
Viga end was removed.

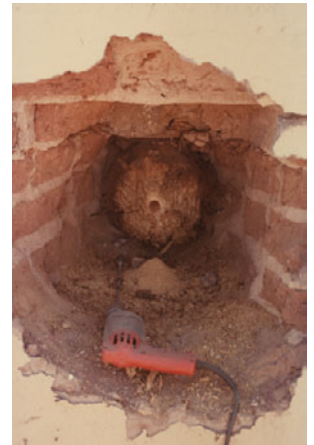
Viga was prepared for splice.

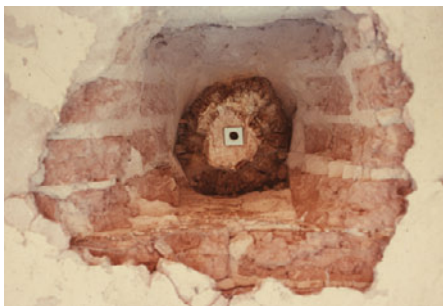
Fiberglass nut was epoxied into place.

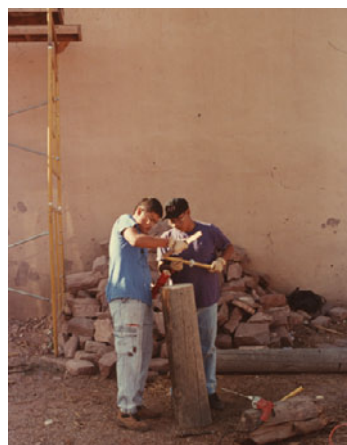
A threaded fiberglass rod was installed in the new tail.

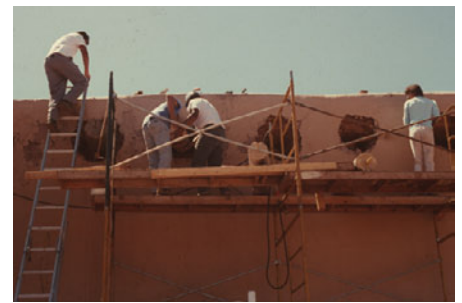
New viga ends were screwed into place.

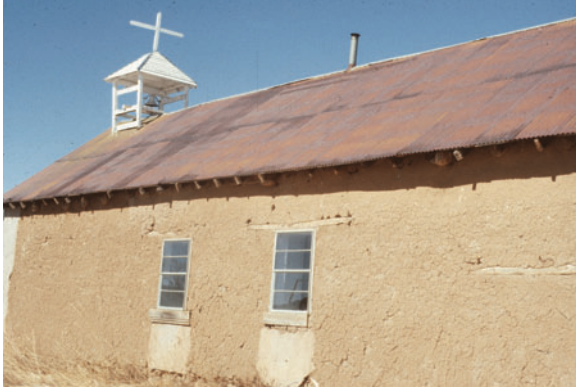
San Acacio de las Golondrinas Golondrinas, New Mexico

Roof leaks and a thick build-up of pigeon droppings in the attic led to the deterioration of the tops of the vigas. They were repaired in situ using fiberglass rods and epoxy.

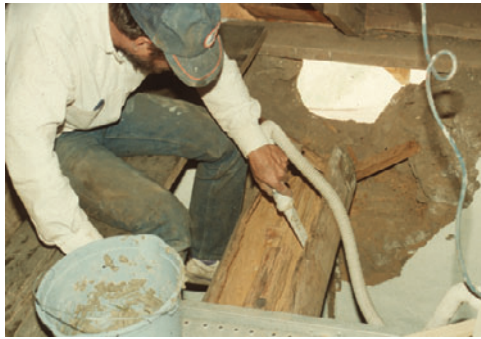
All rot was removed with vigas shored and in place.

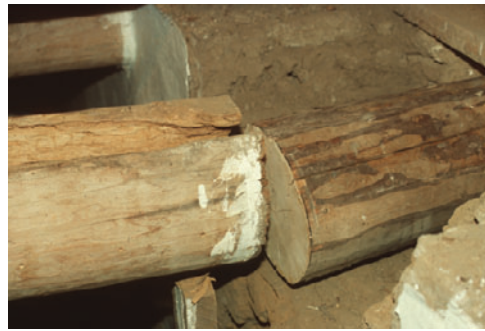
A new tail was matched.

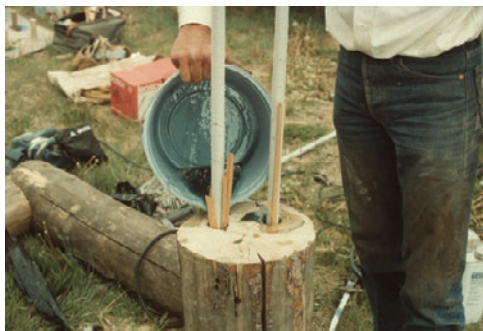
Fiberglass rods were epoxied in place in the new tail.

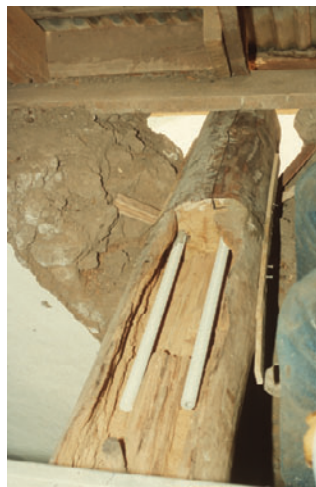
The new tail was joined and the seam sealed with bentonite.

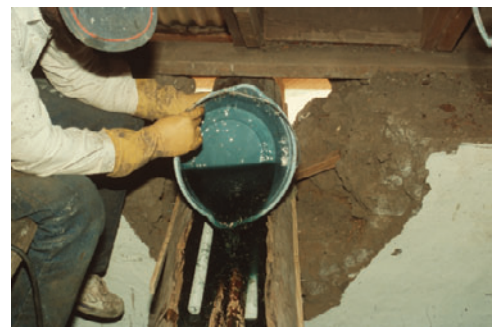
Finally, epoxy was cast into the void.

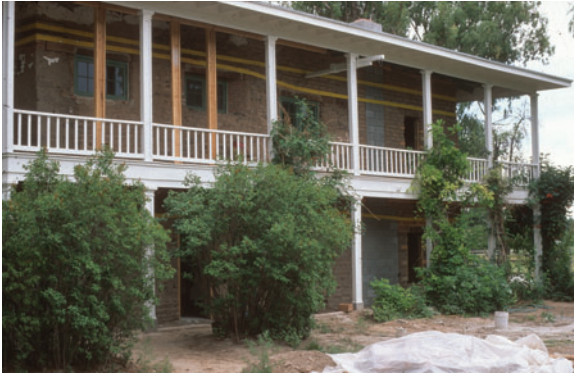
Los Luceros, Alcalde, New Mexico
Unstable walls at this early 19th century adobe hacienda required specialized approaches to stabilization.

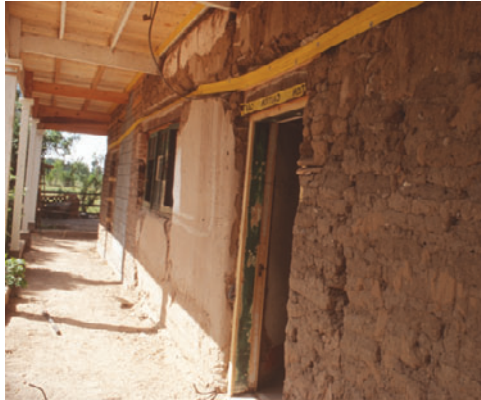
The cement plaster was stripped, revealing degraded walls.

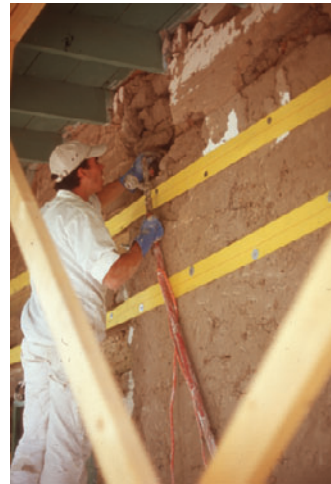
A lightweight, lime-based grout was pumped into voids.

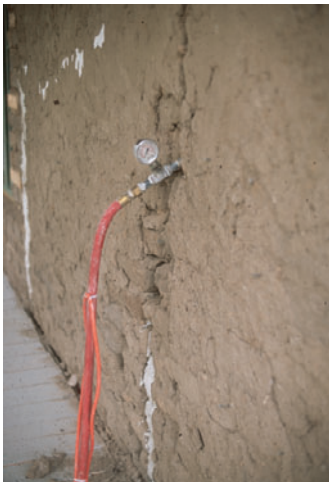
The process was monitored to ensure that no displacement occurred.

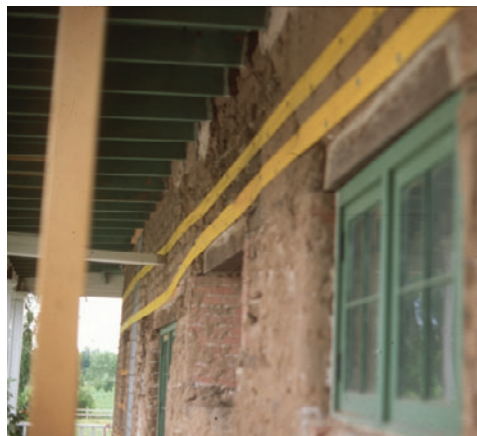
Unstable sections were tied together using polyester strapping.
