# HUTMACHER FARM

This western North Dakota farm was built by Ukrainian-German immigrants in 1926. Abandoned in the early 1980s, the stone and earthen buildings fell rapidly into disrepair. Under leadership from Preservation North Dakota, a Save America's Treasures grant was secured to stabilize the buildings.

Architectural Conservation

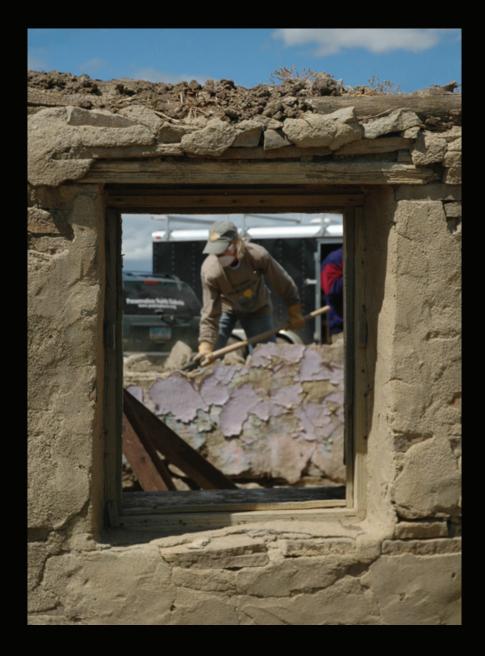
Of particular concern was the replacement of the pitched earthen roofing, comprised of local materials including branches, brush and straw thatch.

Adapting technologies derived from the ancient Hopi village of Oraibi in Arizona, Crocker Ltd designed and implemented an earthen roof over thatch. The layered clays are carefully devised to alternately shed, absorb and release moisture while resisting the harsh climatic conditions of the northern Great Plains.
